Federal Railroad Administration, Office of Railroad Safety

Accident Investigation Summary Report HQ-2023-1813

Norfolk Southern Railway Company (NS)
East Palestine, OH - Derailment
February 3, 2023

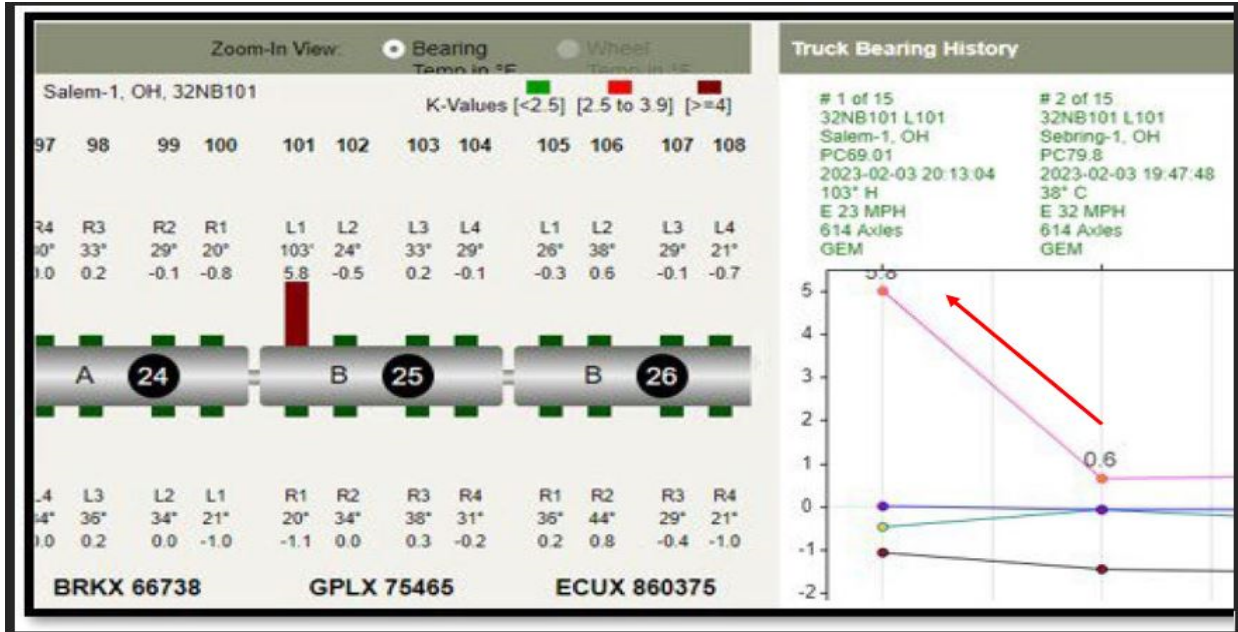
Figure 1: HBD temperature data provided to ATC Desk.

Figure 1 below is a screen shot of the HBD information the WDS system provided to the ATC desk after Train 32N passed the HBD in Salem, Ohio.

HBD Salem, the ATC analyst indicated that at around 8:13 p.m. EST, their attention was split between three absolute alerts on other trains. Due to their attention being focused on the three other trains, the analyst did not notice the non-critical 953 alert the Salem HBD generated.

Per the NS ATC SOP that was in effect on February 3, 2023, there was no specified timeframe in which the analyst was required to initiate any follow-up action to the 953 alert. Furthermore, even if the 953 alert had been noticed by the analyst, there was no requirement for the train to be stopped and inspected in response. An inspection would not have been required by NS policy unless an 853 alert had been logged.
