RAILWAY INVESTIGATION REPORT

R03W0169

DERAILMENT

Canadian Pacific Railway
Freight Train No. 202-16
Mile 86.5, Kaministiquia Subdivision
Carlstadt, Ontario
19 October 2003

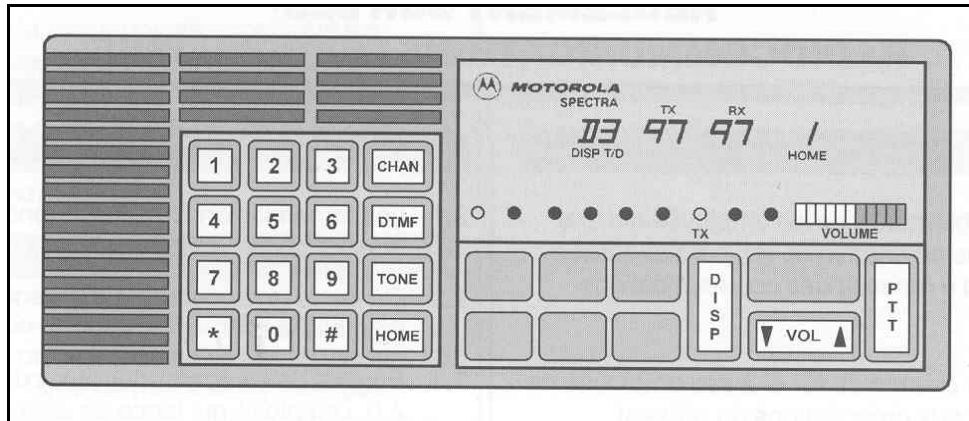
Figure 1. Motorola Spectra radio

The keypad on the Motorola Spectra radio is operated in the same fashion as a telephone push button keypad. During the course of the investigation, several CP employees indicated that it is not uncommon to occasionally select the incorrect channel when operating this type of radio.

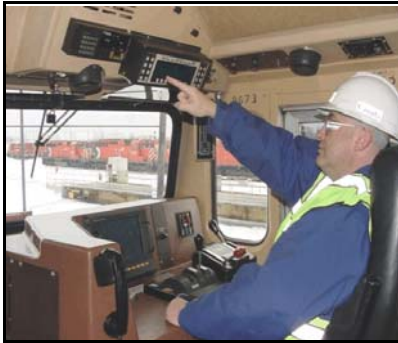
Photo 1. GE AC4400CW

Within the GE AC4400CW cab, a seated individual of average height would have to stretch approximately 6 inches with his left hand or 12 inches with his right hand to reach the locomotive radio. In comparison, because the radio in the GM SD-90 MAC is located to the right of the engineer's chair (above the window) and the radio in the GM SD-40-2 is incorporated into the standard control stand (to the left of the engineer's chair), these radios can be reached more easily than those in the GE cab. Photographs illustrating the location of each radio and the ease of reaching the radio with the right hand are shown below.

The location of the cab radio in the occurrence locomotive, a GE AC4400CW, likely contributed to the error of selecting the incorrect radio channel. The radio is located above the front window to the left of the engineer's seat, which is the present standard for General Electric (GE) locomotives. TSB tests demonstrated that in GE locomotives with this type of cab layout, a seated individual of average height would have to stretch beyond their normal range of motion to reach the radio. This extra distance is approximately 6 inches with the left hand or 12 inches with the right hand. In comparison, radios in the GM SD-40-2 and SD-90 MAC locomotives, which are also used at CP, are easily reached by an individual of average height seated in the

engineer's chair. Although locomotive engineers are not restrained in their seats, having to reach beyond one's normal range of motion to access the radio buttons increases the probability of an error when entering the radio channel.
